Repair of the Historic Arched Bridge in Naila with CarboBeton

1. Introduction

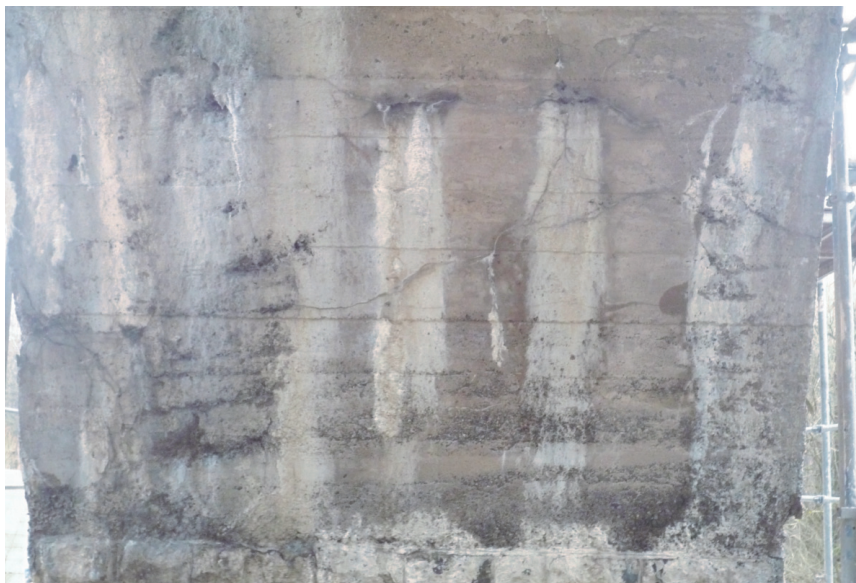
All arches were characterized by numerous transversal and networklike cracks as well as clearly visible concrete section joints with distinct sinterings, which were deposited on large areas of the concrete surface.

Illustration 01: Damage existing at the bottom side of the arches.
Photo: Ammar Al-Jamous

Obviously, the formation of cracks was caused by the concrete technology of this time, by the composition of the concrete with an imbalanced mixing ration of the additives as well as the shift-wise introduction by hand without the respective tools for the compacting of the concrete. The result was a defective respectively disturbed concrete microstructure with the formation of a network or separating cracks caused by an early shrinkage and/or plastic settlements as well as cavities and defects of up to 1.5 cm in diameter. Here and there clearly visible gravel pockets were an additional indication for the varying quality of the concrete. As another reason for the distinct cracks, moisture penetrations with sinterings in combination with the effects of frosts have to be mentioned. Over the long standing time of 100 years, this resulted in an increase in the formation of cracks and spillings in places.

After a time-consuming examination of possible alternatives, due to the obvious advantages it has been decided to repair the superstructure at the bottom side with TUDALIT textile reinforced concrete. The bottom side of the superstructure (arches) should be repaired with two layers of carbon reinforcement embedded in fine concrete.

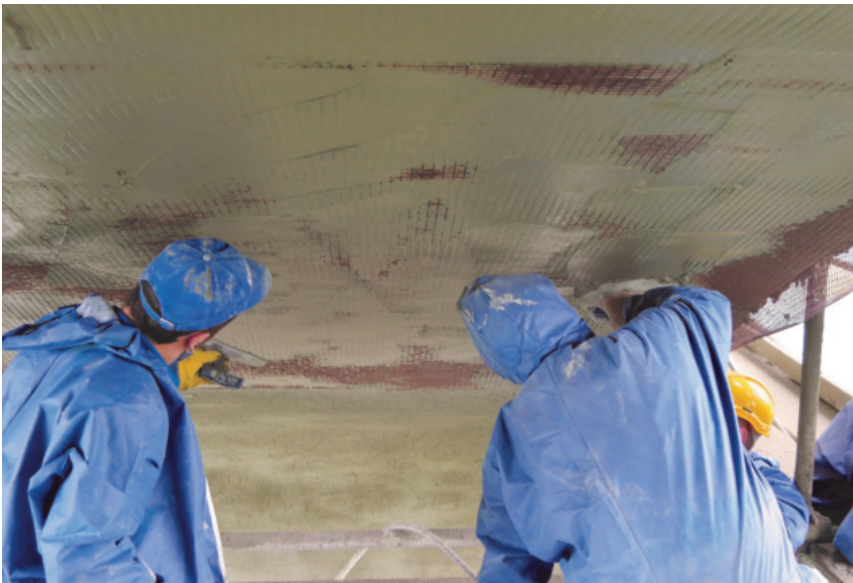
Illustration 02: Fixing of the carbon reinforcement in the fine concrete.
Photo: Ammar Al-Jamous

The reinforcement began with the application of the first layers of fine concrete onto the prepared old concrete. Into this, the first textile reinforcement layer was introduced. Subsequently, the freshly introduced textile reinforcement was once again covered with a layer of fine concrete.

As the reinforcement works had to be interrupted due to the sizes of the areas to be reinforced, the last layer of fine concrete was roughened up with the stroke of a broom prior to the exceeding of the application life. The next day the spraying of a new layer of fine concrete was performed into which the second layer of the carbon reinforcement was built in. Then, a last fine concrete layer served as a covering of the second reinforcement layer. The layer built-up of the carbon concrete was roughly 20 mm in total.

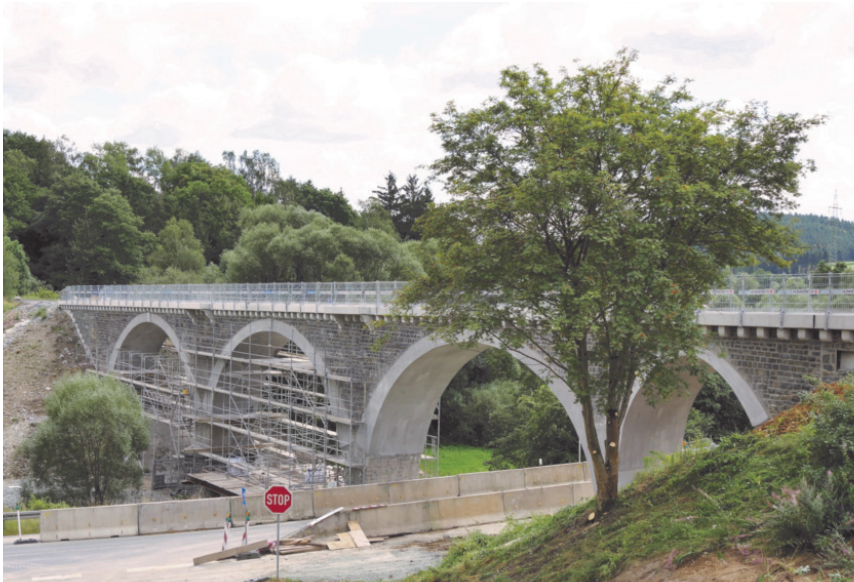
Illustration 03: View on the finished bridge. Photo: Ammar Al-Jamous
